Rotary Draw Mindbenders and their Solutions

OMNI-X INC.

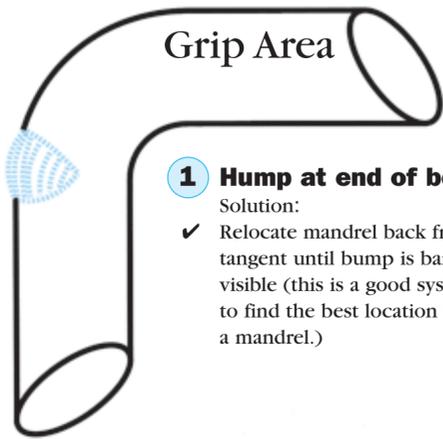
1 Hump at end of bend.

- Solution:
- ✓ Relocate mandrel back from tangent until hump is barely visible (this is a good system to find the best location for a mandrel.)

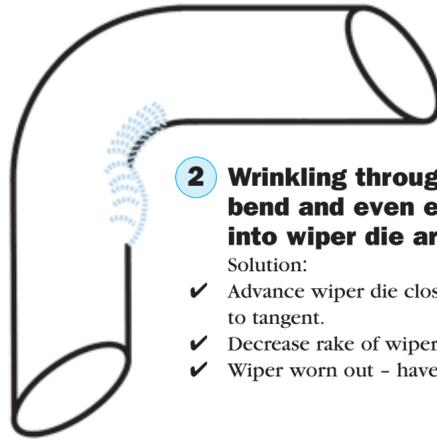
2 Wrinkling throughout bend and even extending into wiper die areas.

- Solution:
- ✓ Advance wiper die closer to tangent.
 - ✓ Decrease rake of wiper die.
 - ✓ Wiper worn out - have replaced.

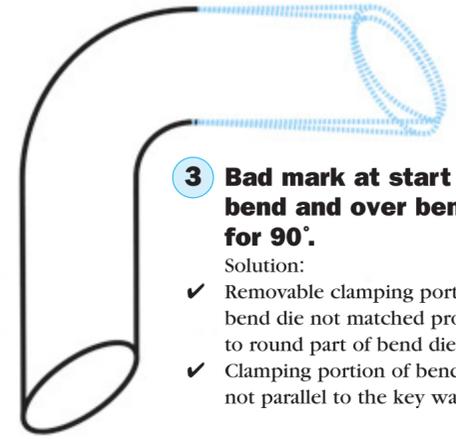
3 Bad mark at start of bend and over bend for 90°.

- Solution:
- ✓ Removable clamping portion of bend die not matched properly to round part of bend die.
 - ✓ Clamping portion of bend die not parallel to the key way.

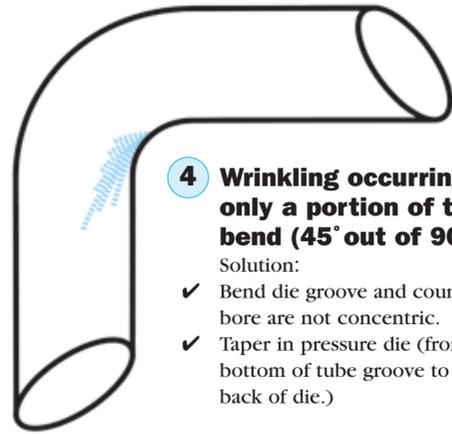
4 Wrinkling occurring for only a portion of the bend (45° out of 90°.)

- Solution:
- ✓ Bend die groove and counter-bore are not concentric.
 - ✓ Taper in pressure die (from bottom of tube groove to back of die.)

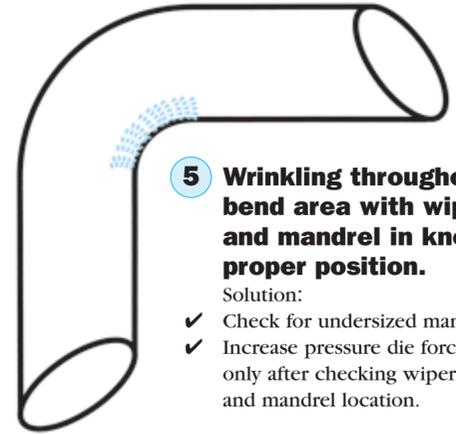
5 Wrinkling throughout bend area with wiper and mandrel in known proper position.

- Solution:
- ✓ Check for undersized mandrel.
 - ✓ Increase pressure die force only after checking wiper fit and mandrel location.

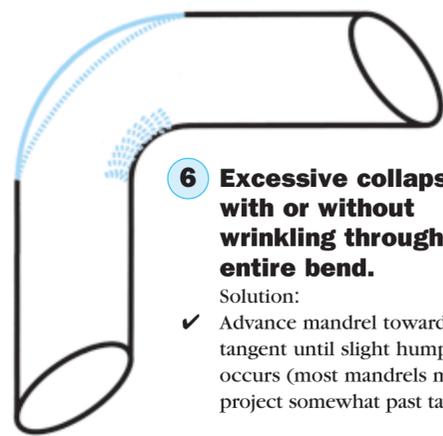
6 Excessive collapse with or without wrinkling throughout entire bend.

- Solution:
- ✓ Advance mandrel toward tangent until slight hump occurs (most mandrels must project somewhat past tangent.)

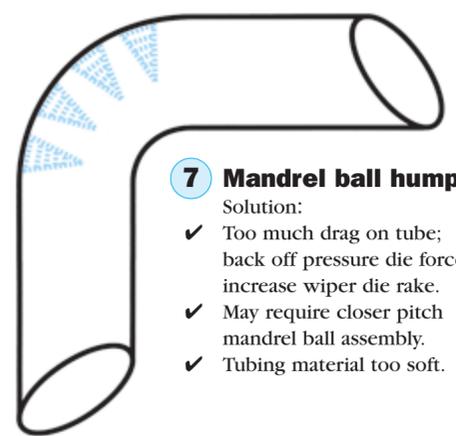
7 Mandrel ball humps.

- Solution:
- ✓ Too much drag on tube; back off pressure die force - increase wiper die rake.
 - ✓ May require closer pitch mandrel ball assembly.
 - ✓ Tubing material too soft.

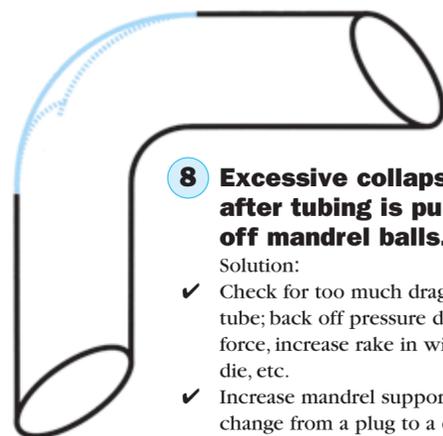
8 Excessive collapse after tubing is pulled off mandrel balls.

- Solution:
- ✓ Check for too much drag on tube; back off pressure die force, increase rake in wiper die, etc.
 - ✓ Increase mandrel support, change from a plug to a one ball, from a 2 ball to a 3 ball mandrel, etc.

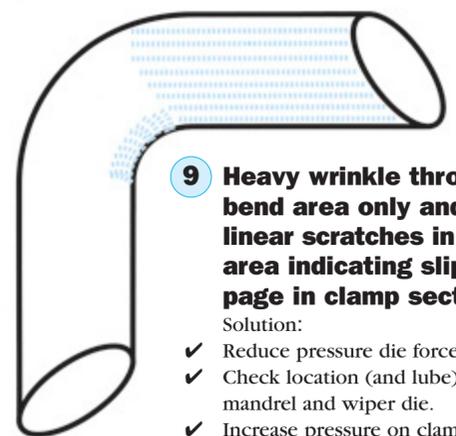
9 Heavy wrinkle through bend area only and linear scratches in grip area indicating slippage in clamp section.

- Solution:
- ✓ Reduce pressure die force.
 - ✓ Check location (and lube) of mandrel and wiper die.
 - ✓ Increase pressure on clamp die.
 - ✓ Use serration, knurling or carbide spray in clamp area.

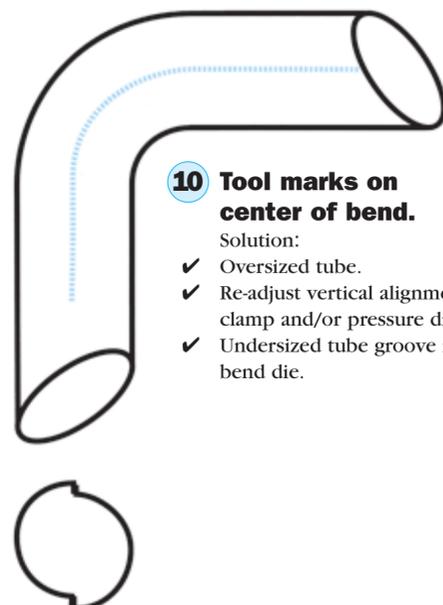
10 Tool marks on center of bend.

- Solution:
- ✓ Oversized tube.
 - ✓ Re-adjust vertical alignment of clamp and/or pressure die.
 - ✓ Undersized tube groove in bend die.

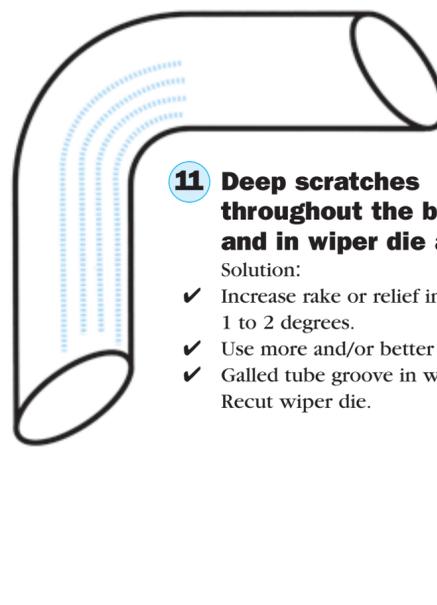
11 Deep scratches throughout the bend and in wiper die area.

- Solution:
- ✓ Increase rake or relief in wiper die 1 to 2 degrees.
 - ✓ Use more and/or better lubrication.
 - ✓ Galled tube groove in wiper die. Recut wiper die.

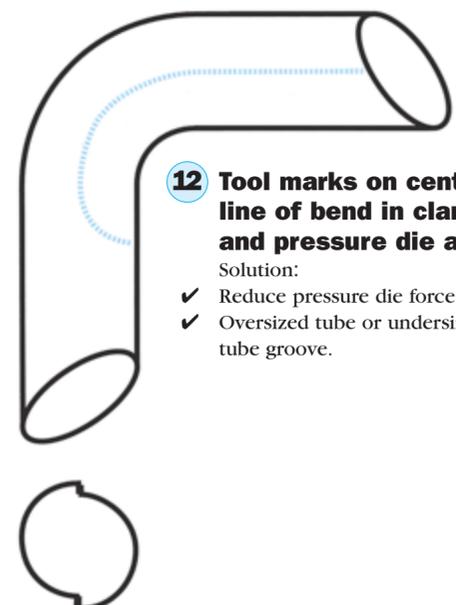
12 Tool marks on center line of bend in clamp and pressure die area.

- Solution:
- ✓ Reduce pressure die force.
 - ✓ Oversized tube or undersized tube groove.
